50 year evaluation of St Louis’ Gateway Arch

Catherine M. Houska,
TMR Consulting, Pittsburgh, USA

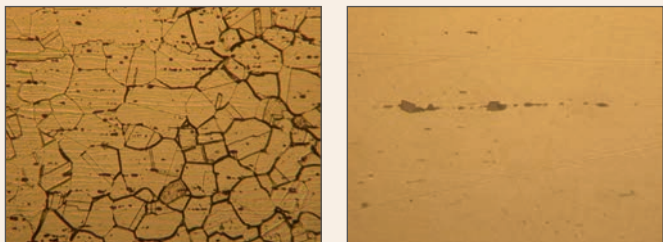
Even with today’s low-carbon levels, the high levels of heat input associated with repeated welding of plate could cause sensitisation (precipitation of carbides at grain boundaries), which decreases the corrosion resistance of the stainless steel plate adjoining the weld. Sensitisation was found in the microstructures of all the samples, but neither they nor any area that was inspected exhibited the characteristic corrosion pattern associated with sensitisation-related corrosion. Given the high carbon levels typical of stainless steel produced prior to the introduction of the AOD, the sensitisation observed during weld cross sectioning is not surprising. Since the samples were from an area known to have been repeatedly re-welded, we cannot be certain that welds higher on the structure were also sensitised. After 50 years of service, the lack of the characteristic pattern associated with sensitisation related corrosion indicates that Type 304 is suitable for the environment.

SEM/EDS confirmed the presence of manganese sulfides in the base metal. Sulfides were seen in all the samples and can make the stainless steel more susceptible to pitting corrosion if the surface is not chemically passivated. The post-fabrication cleaning procedures indicated that passivation was to be done although we did not find confirmation of it. This would have removed surface sulfides and improved corrosion resistance.

Figure 1(left) Micrograph of W1 in the etched condition showing sensitised grains (right) and grains that are not sensitised (left). (256x). Figure 2 (right): Micrograph of a plate inclusion, W1, as-polished condition. (517x) (Photos taken by TMR in 2014).

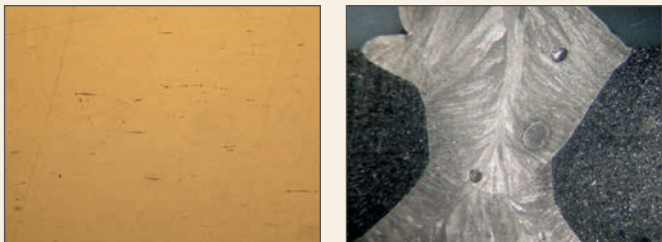
Figure 3: Micrograph of manganese sulfide stringers in the plate, W1, as-polished condition. (256x). Figure 4 (right): Macrograph, W4, etched condition, showing the most significant weld porosity found in any sample. The largest void near mid thickness has an approximate diameter of 0.04". (Photos taken by TMR in 2014)

All of the sample welds appeared to be full penetration. Numerous weld imperfections were documented during visual examination and microscopic evaluation of the weld samples, including small areas of porosity, weld spatter, weld slag and a shallow weld undercut. No cracking or significant corrosion was found at these imperfections after 50 years of service so they were not considered a concern. Figures 1 through 5 provide representative images of these imperfections, the inclusions and the sensitisation.

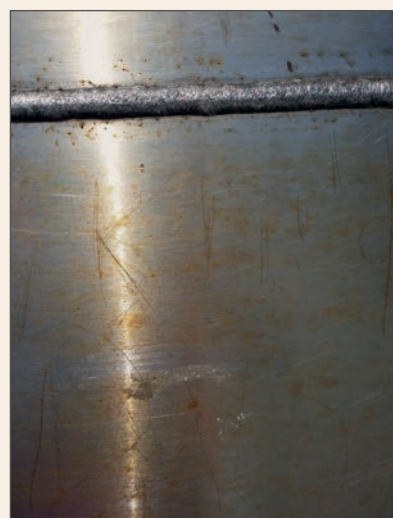
Figure 6. Superficial corrosion staining at the base caused by deicing salt exposure. (Photo taken by author in 2014).

Other than very small, localized areas, the only corrosion staining observed on the surface was at the base, which would not be as effectively rain-washed as elevated areas. This light superficial staining was caused by microscopic deicing salt related pitting and could easily be removed. The environment is not corrosive enough for any of these deposits to have caused more than superficial discoloration after 50 years, so their presence is a purely aesthetic issue. Figure 6 shows superficial corrosion staining at the base.
