50 year evaluation of St Louis’ Gateway Arch

Catherine M. Houska,
TMR Consulting, Pittsburgh, USA

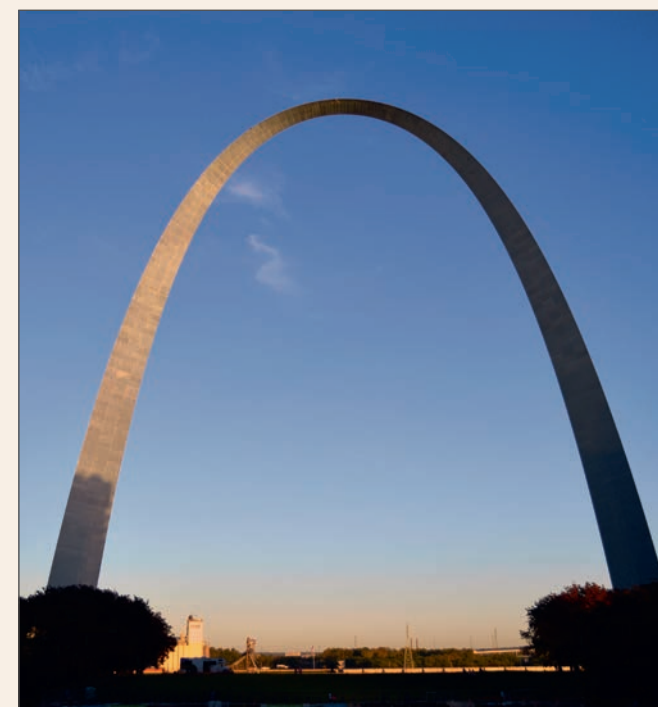
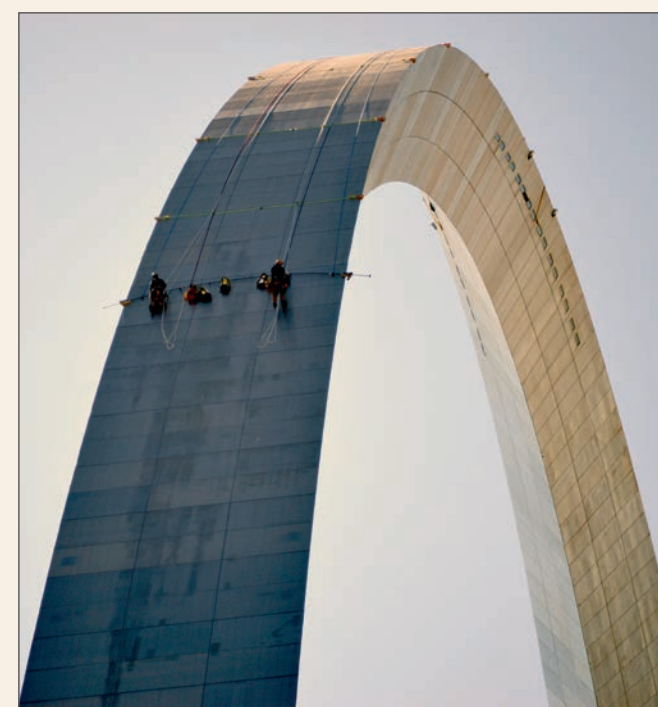
Inspectors used gunshot residue kits with specialised SEM/EDS sample collection tapes to gather samples from the surface of the Arch.
